ARCTIC COASTAL EROSION: AN OVERVIEW

H. Jesse Walker, Geologist
Louisiana State University

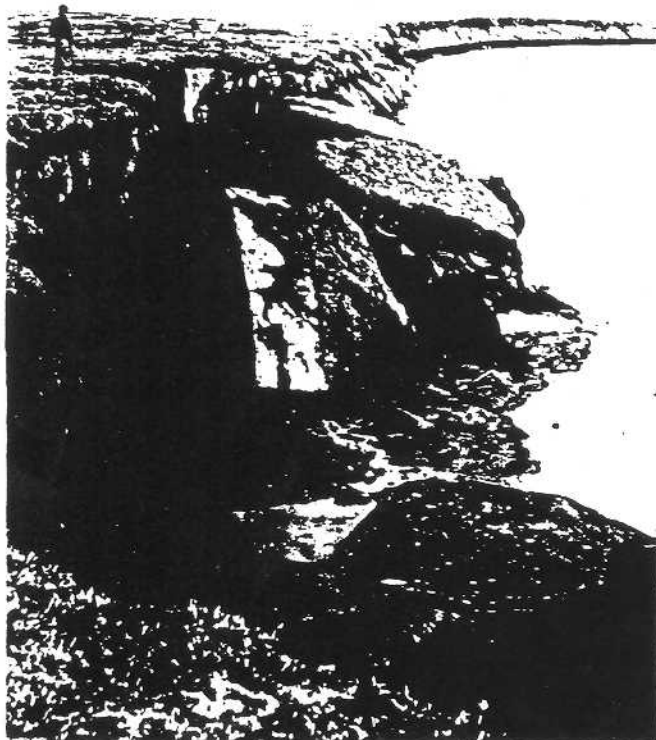
Photo 9 Collapse blocks after undercutting at Nuiqsut.

occurs. This flowing water impacts the banks it flows against in two ways. First, the temperature differential will result in thawing of snowdrifts and then the permafrost of the bank. Second, the moving water will remove and transport the loosened materials causing bluff retreat. In the process a thermo-erosional niche will develop - i.e. undercutting of the permafrost bluff occurs. In time undercutting can lead to block collapse and rapid retreat. Much of this type of collapse occurs along ice wedges and it is not uncommon to have most of an ice-wedge polygon undercut and collapse (Photo 9 and Fig. 4).

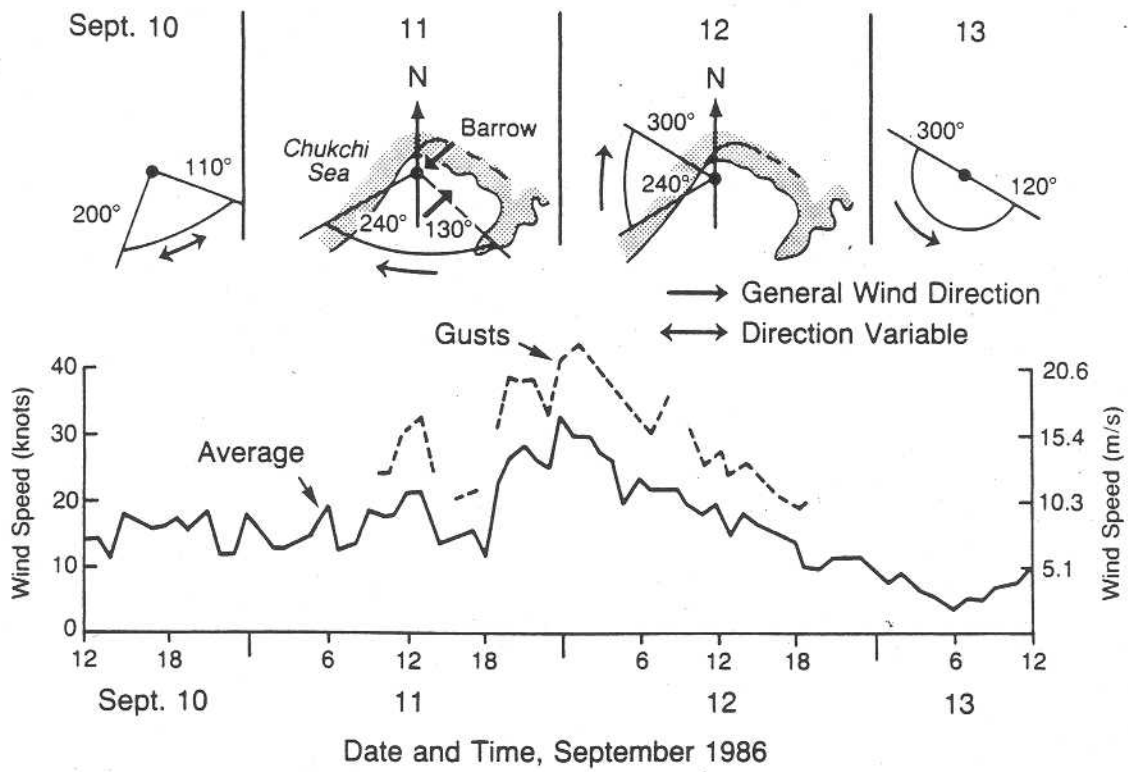
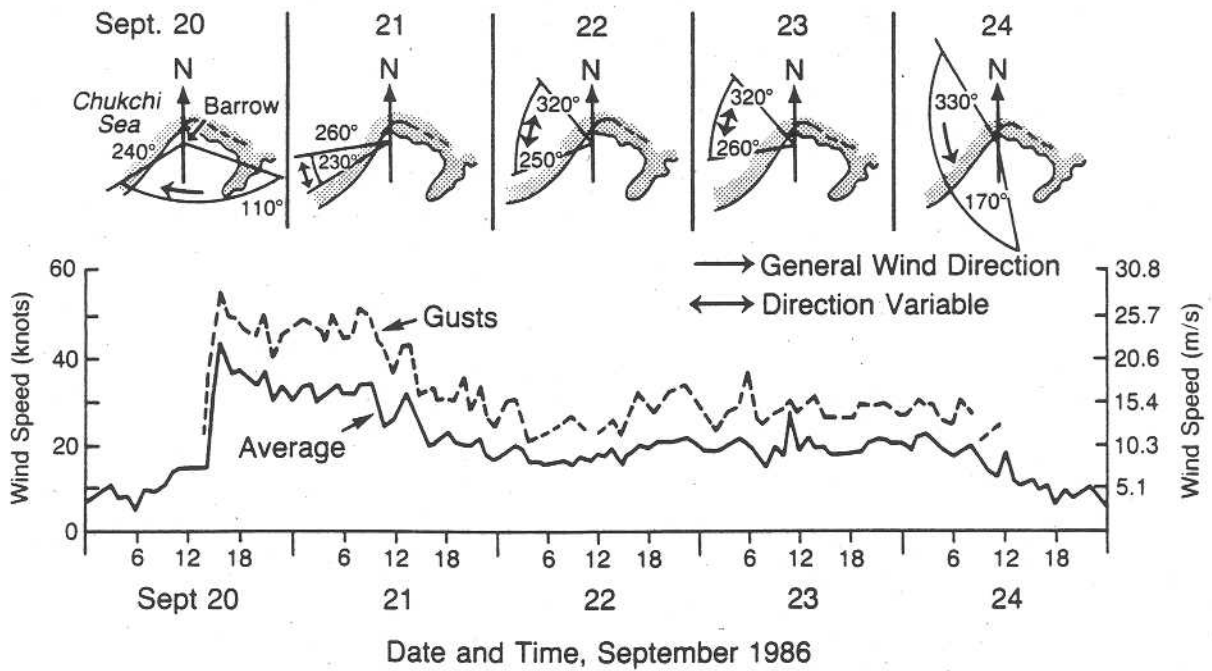
Fig. 6. Wind direction and speed during the 2 severe storms of September 1986.

September 1986, which caused major bluff retreat at Barrow (Photo 10) and Wainwright, were especially severe. The winds accompanying them were not as strong as many that blow along the coast. However, they lasted longer so that wave attack was continuous over a long period of time (Fig. 6).
